PILOMAT 275/M50-1200
CRASH TESTED
M50 (K12) RATING
AMERICAN CERTIFICATION
ASTM F2656-07 STANDARD

F2656-07
PILOMAT
275 / M50-1200
RETRACTABLE
BOLLARD
BY 2025-07 M50
04 / 18 / 18
KARG'S
Engineering

PASS PM 275/M50-1200A

TR-P31047-01-NC

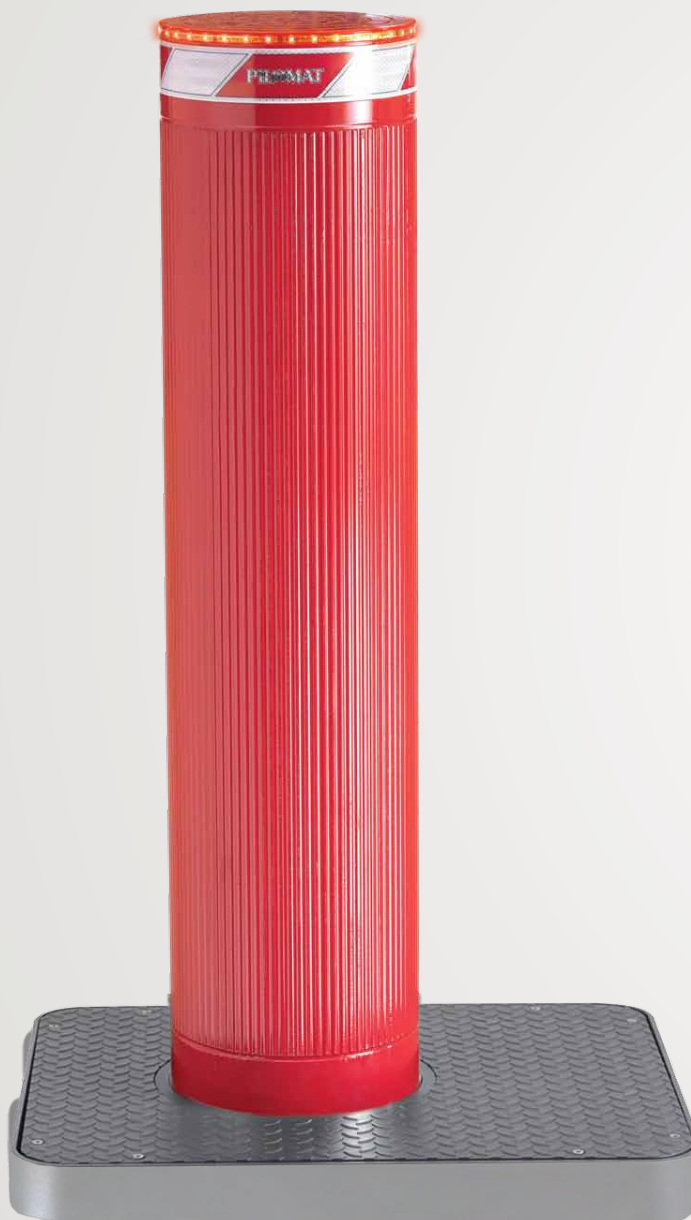
275/M50 1200A

M50/K12 Automatic hydraulic anti-terrorism bollards with built-in pump

- Ø 275 mm / h 1200 mm
- 2.000.000 joules
- 700.000 joules

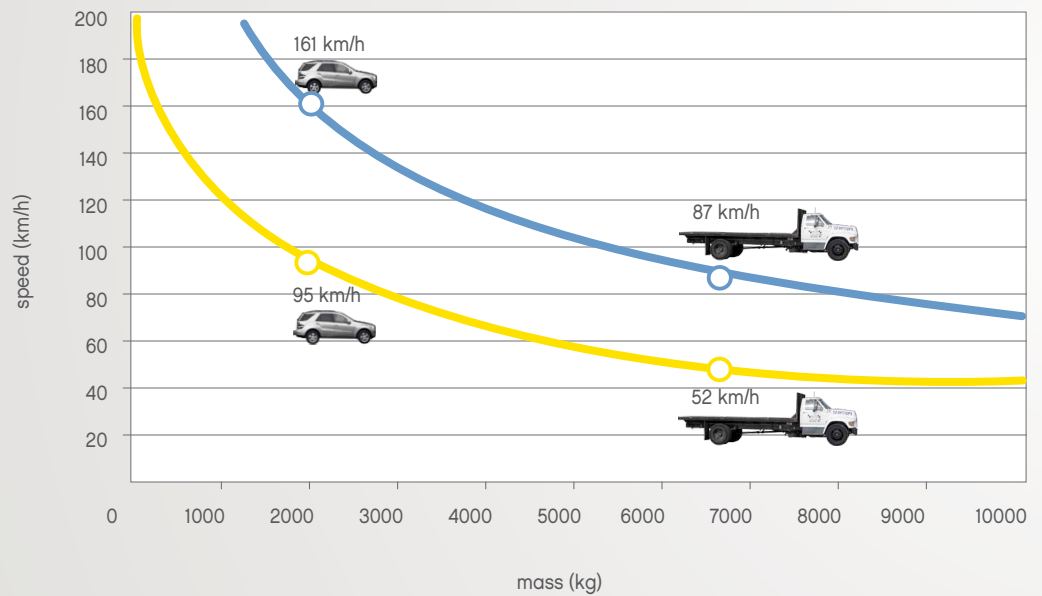
PILOMAT 275/M50 1200A

- 2.000.000 JOULES
- 700.000 JOULES

BREAKOUT RESISTANCE

The resistance to breakage at a given threshold applies to the impact of a vehicle causing the Pilomat permanent damage in its active and structural mechanisms. The Pilomat, although damaged, provides the vehicle stop within a metre from the point of collision.

IMPACT RESISTANCE

Resistance to impact at a given threshold indicates that the impact of a vehicle does not cause the PILOMAT blocking or damage to the structural and action mechanisms. The Pilomat's continued functionality and safety are guaranteed.
