**PILOMAT 275/M30-1200
CRASH TESTED
M30 (K4) RATING
AMERICAN CERTIFICATION
ASTM F2656-07 STANDARD**

P32052-01
PILOMAT
275 / M30 - 12000
RETRACTABLE
BOLLARD
ASTM F 2656-07 M30
03 / 20 / 12
AKARCO
Engineering

TEST REPORT FOR:

PILOMAT 275/M30-1200A

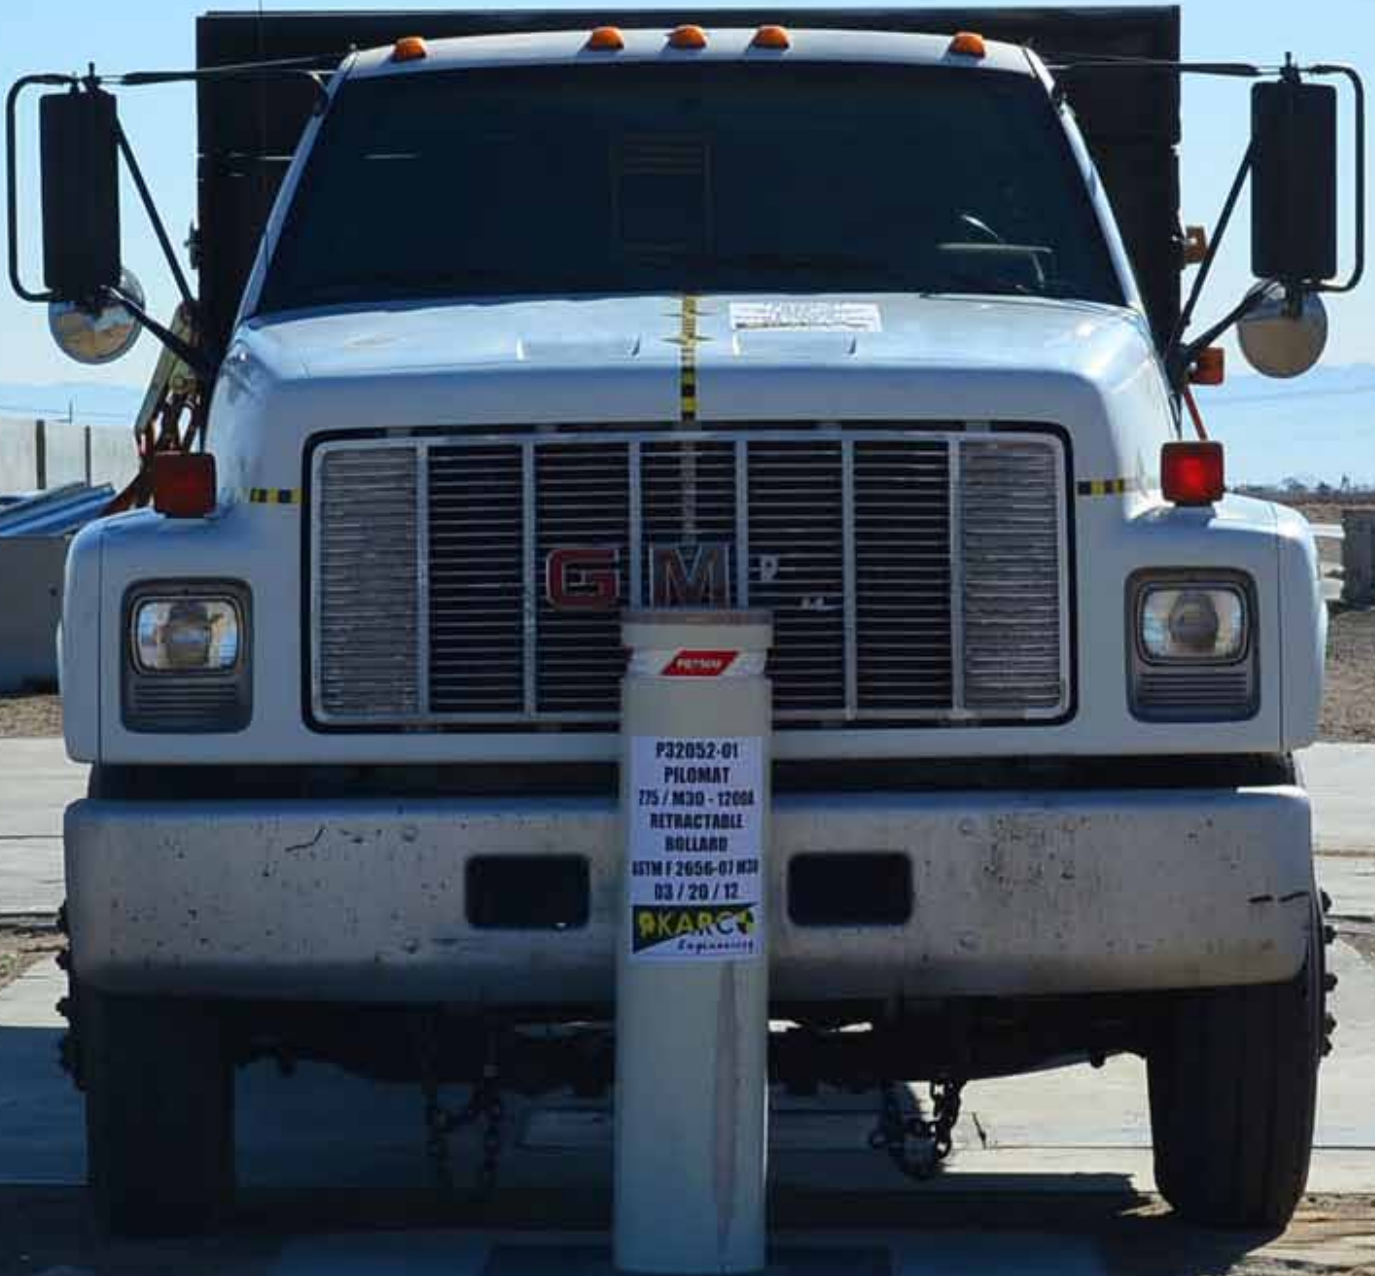
Crash Test - M30 (K4) Rating
American Certification - ASTM F2656-07 Standard
Performed at Karco Engineering, LLC
Automotive Research Center, Adelanto CA, U.S.A.

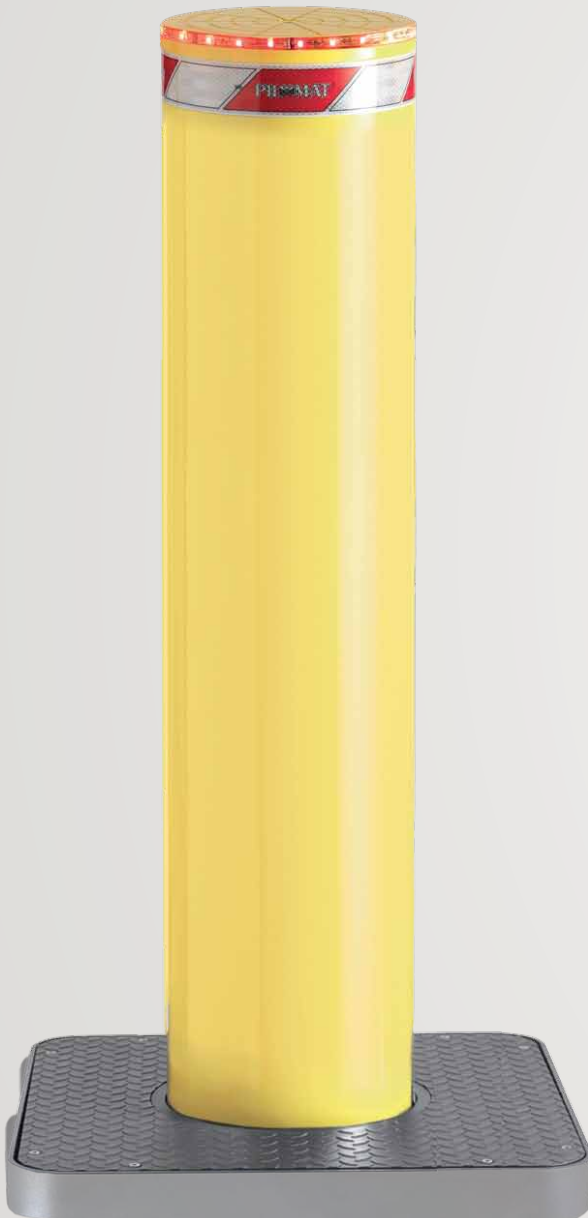
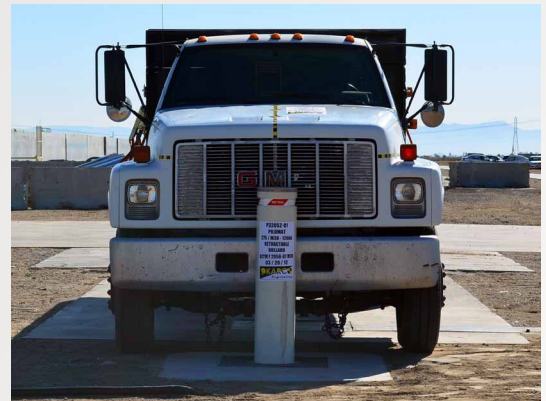
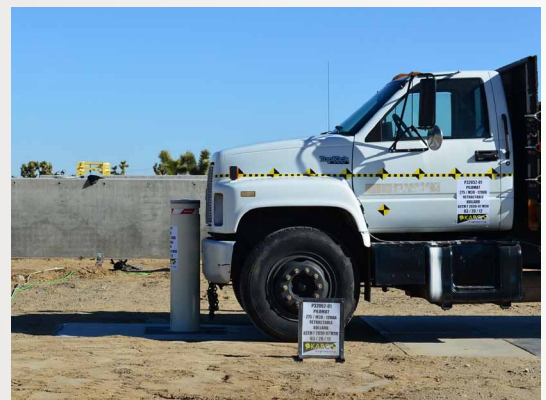
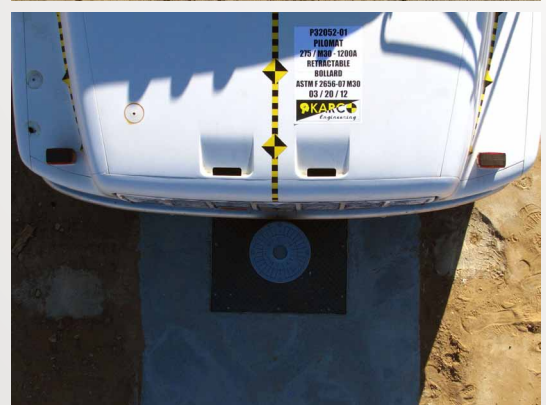
275/M30 1200A

M30/K4 Automatic hydraulic anti-terrorism bollards with built-in pump

- Ø 275 mm / h 900 mm
- 1.200.000 joules
- 700.000 joules

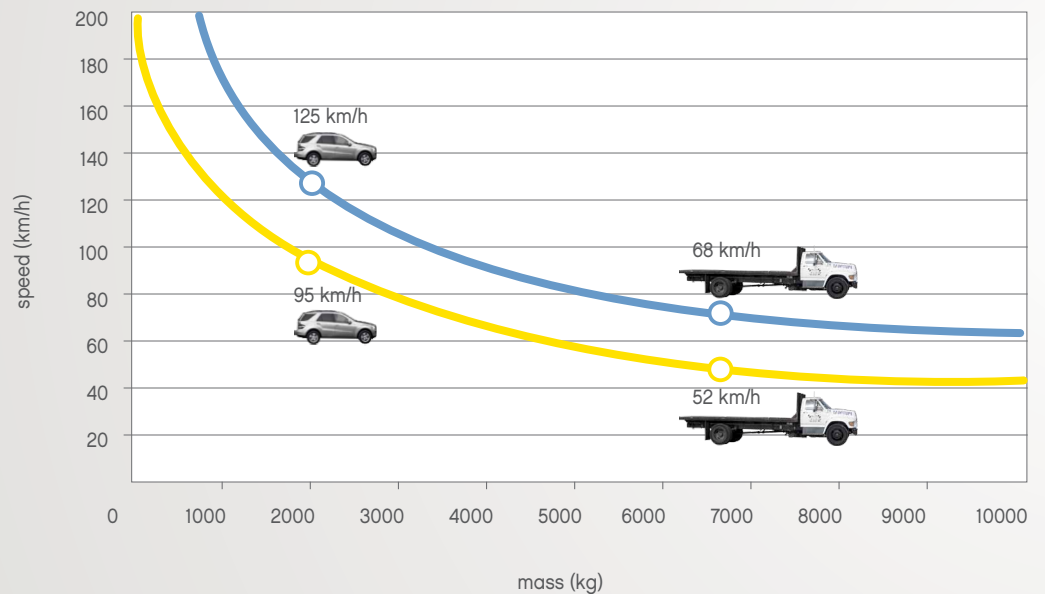
PILOMAT 275/M30 1200A

- 1.200.000 JOULES
- 700.000 JOULES

BREAKOUT RESISTANCE

The resistance to breakage at a given threshold applies to the impact of a vehicle causing the Pilomat permanent damage in its active and structural mechanisms. The Pilomat, although damaged, provides the vehicle stop within a metre from the point of collision.

IMPACT RESISTANCE

Resistance to impact at a given threshold indicates that the impact of a vehicle does not cause the PILOMAT blocking or damage to the structural and action mechanisms. The Pilomat's continued functionality and safety are guaranteed.

275/M30 1200A	
MOVING CYLINDER	FE 510 STEEL (IRON)
MOVING CYLINDER NOMINAL DIAMETER	275 mm
MOVING CYLINDER HEIGHT	1200 mm
MOVING CYLINDER FE 510 STEEL THICKNESS	15 mm
MOVING CYLINDER FE 510 STEEL FINISH	POLYESTER POWDER PAINT – STANDARD GREY ANTHRACITE
OTHER MOVING CYLINDER FINISH	RIBS ON CYLINDER SURFACE - 316 AISI STAINLESS STEEL BRUSHED COVERING 1,5 mm
REFLECTING ADHESIVE STRIP	YES - HEIGHT 55 mm
RISING SPEED	20 cm/sec
LOWERING SPEED	22 cm/sec
MANUAL EMERGENCY LOWERING	YES (VERSION WITH RELEASE NO 220 = AUTOMATIC LOWERING)
CONNECTION LINE TO CONTROL UNIT	STANDARD 10 m (MAXIMUM LENGTH: 80 m)
HYDRAULIC PUMP	BUILT-IN INTO THE PILOMAT
PROTECTION CLASS	IP 67
TYPE OF USE	INTENSIVE - LIFE AVERAGE 2.000.000 MOVEMENTS - 2.000 MOVEMENTS/DAY
IMPACT RESISTANCE (WITHOUT DEFORMATION)	700.000 J
BREAKOUT RESISTANCE	1.200.000 J
OPERATING TEMPERATURE	- 40°C + 70°C (FOR LOW TEMPERATURES SEE HEATING RESISTANCE)
NOMINAL PILOMAT WEIGHT (WITHOUT PIT)	385 kg
